Manhole Inspection Summary

Manhole # S13OO1012MH

Insp Date: **11/29/06 2:30 PM**

Location Address: **2813 RUSCOMBE LN**

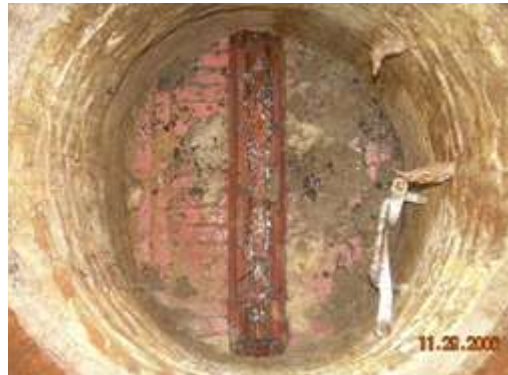
Top View

Bench ☒ Exists Material: **Brick** ☐ Parged ☒ **Debris** (not Condition related)

Steps Count: **2** Missing: **1** ☒ **Corroded**

Surcharge ☒ **Evidence Of Surcharge** Depth: **1** (ft.) ☐ Active Surcharge Present

Evidence of surcharge - Bench debris.
Corroded and missing steps.

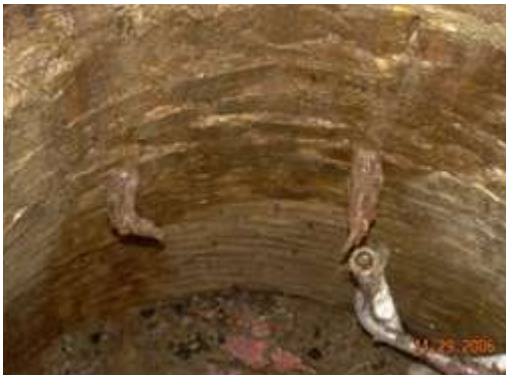
Defect

Infiltration: ☐ None ☐ Joint ☐ Cracks ☒ **Mortar** ☐ Roots ☒ **Wall**

Barrel infiltration. Corroded and missing step.

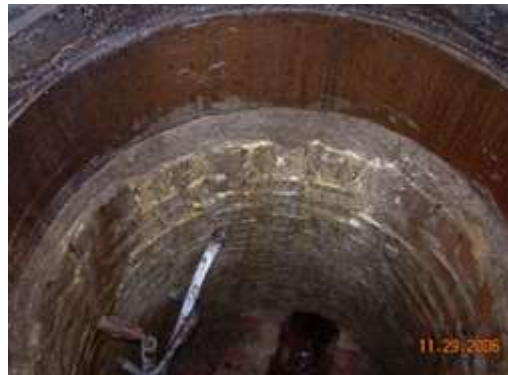
Defect

Frame Offset: **0** (in.) Condition: ☐ Sound ☐ Cracked ☒ **Leaks**

Condition: ☐ Sound ☐ Cracked ☐ Root Intrusion ☐ Loose Brick ☒ **Deteriorated**

Infiltration: ☐ None ☒ **Joint** ☐ Cracks ☒ **Mortar** ☐ Roots ☒ **Wall**

Frame leaks. Adjustment deterioration
and infiltration.

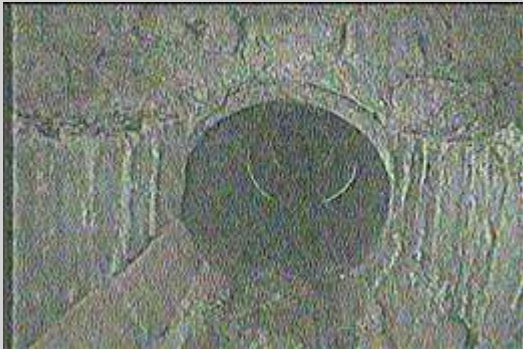
8 in. Circular Gravity Sewer Pipe Out @ 12 O'Clock

Infiltration: **Evidence** Pipe Seal Cond: **Cracked**

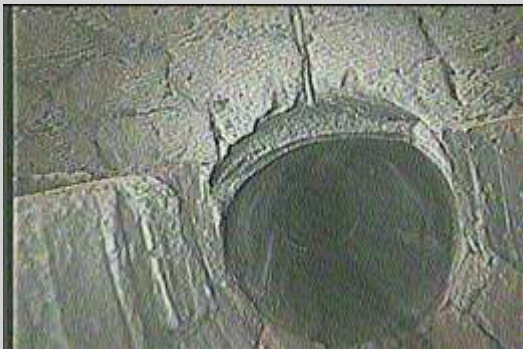
8 in. Circular Gravity Sewer Pipe In @ 6 O'Clock

Condition: ☐ Sound ☐ Cracked ☐ Root Intrusion ☒ **Deteriorated** ☐ Leaks ☐ Debris

Channel deterioration.

Infiltration: **Evidence** Pipe Seal Cond: **Broken**
